Proposed Emissions Modification, Part A: EA288 GEN3 MY 2015
Test Group FVGAV02.0VAL
Automatic and Manual Transmissions

Repair Instructions

August 2nd, 2016

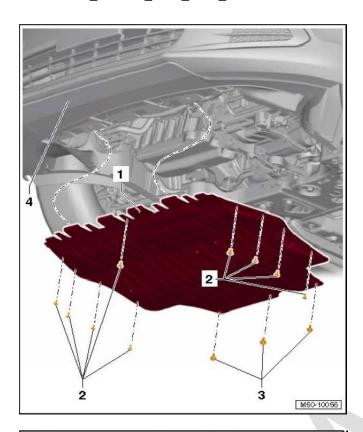
- Remove bolts <2 and 3>.
- Pull noise insulation <1> back, out of front bumper cover <4>.

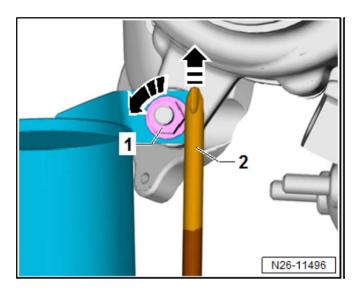
Apply screwdriver <2> on side of nut <1> and unscrew nut while simultaneously pressing up on nut

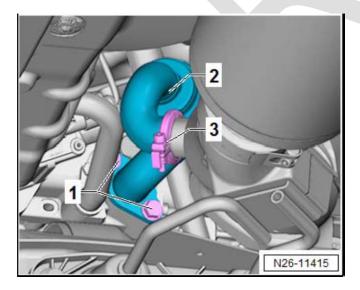
- Set new exhaust gas recirculation filter <2> with new seals in place, screw in bolts <1> and tighten to 9 Nm.
- Position clamp <3> and tighten to 3.5 Nm.

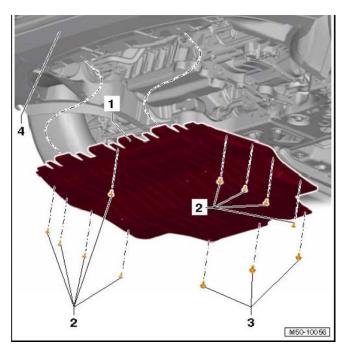
- Push noise insulation <1> forward into front bumper cover <4>.
- Screw in bolts <2> and new bolts <3> and tighten as follows:
  - o Bolt <2>: 2 Nm
  - Bolt <3>: 6 Nm (renew)

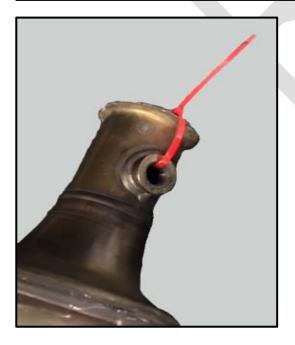
Install the validation strap to the NOx catalytic converter <as shown> to confirm that the proper part is being returned for core.

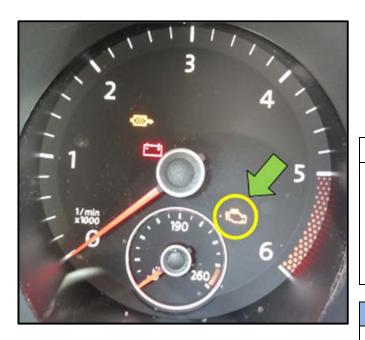
- Check for illumination of the MIL <arrow>.
  - If MIL is illuminated, STOP, create a VTA ticket and contact the Volkswagen Technicians Helpline.
  - If MIL is not illuminated, continue the work procedure.

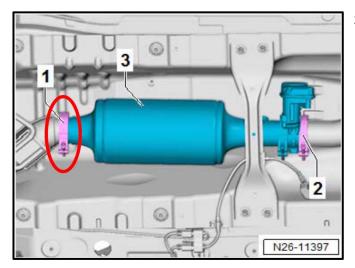
- If the vehicle is a 2010 Model Year Vehicle with a one-piece DPF and NOx Trap system that has a welded joint as shown in location <A>:
  - STOP, create a VTA ticket and contact the Volkswagen Technicians Helpline.
     DO NOT continue with the repair at this time.

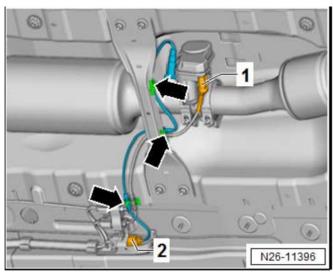
1 2 2 2 N26-11397

- Disconnect »brown« connector for oxygen sensor after catalytic converter -G130- <2>.
   Remove plug from retainer.
- Open fasteners for heat shield and pull connector
   off exhaust door control unit -J883- and thread wiring out of retainers <arrows>.

Loosen clamps <1 and 2> and remove NOx storage catalytic converter together with exhaust door control unit -J883-.

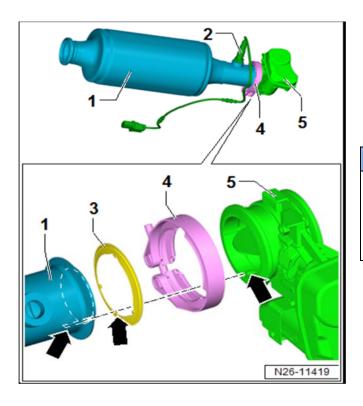
- Screw new oxygen sensor after catalytic converter -G130- <2> into new NOx storage catalytic converter <1> and tighten to 52 Nm using socket, 22 mm -T10491-.
- Set new exhaust door control unit -J883- <5> with new seal <3> on NOx storage catalytic converter <1>. Note notches <arrows>.

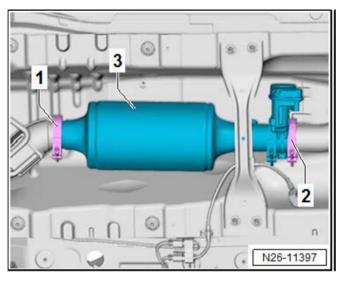
- Set clamp 1K0 253 725 B <2> in place and engage and torque to 7 Nm.
- Set clamp 1K0 253 725 <1> in place and engage. Then tighten to 7 Nm.

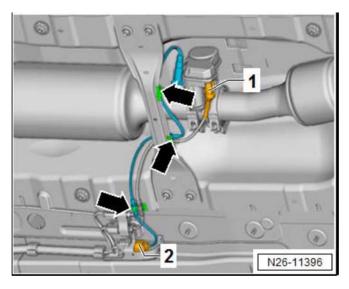
- Connect »brown« connector for oxygen sensor after catalytic converter -G130- <2> and attach to bracket.
- Push connector <1> onto exhaust door control unit. Secure lines in retainers <arrows>.

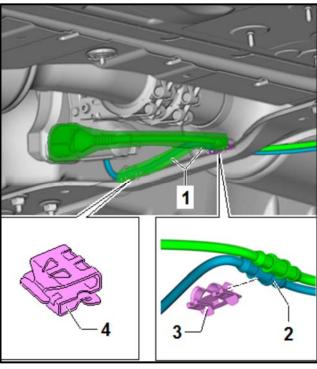
- Wrap new heat insulation mats <1> around wiring and close fasteners.
- Place wires <2> in clips <3 and 4>.

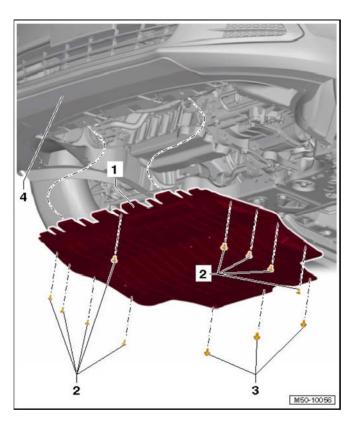
- Remove bolts <2 and 3>.
- Pull noise insulation <1> back, out of front bumper cover <4>.

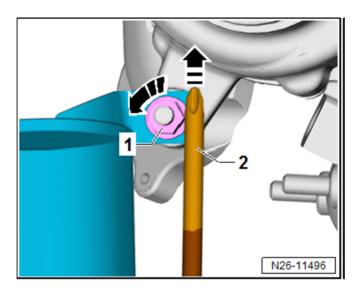
Apply screwdriver <2> on side of nut <1> and unscrew nut while simultaneously pressing up on nut.

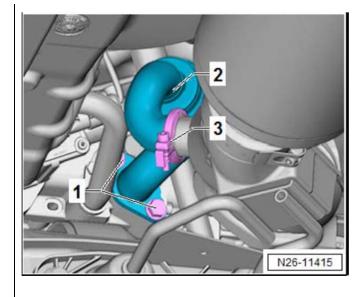
- Set new exhaust gas recirculation filter <2> with new seals in place, screw in bolts <1> and tighten to 9 Nm.
- Position clamp <3> and tighten to 3.5 Nm.

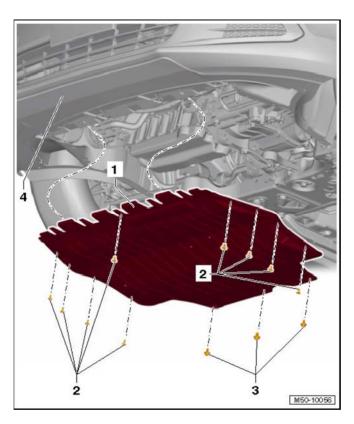
- Push noise insulation <1> forward into front bumper cover <4>.
- Screw in bolts <2> and new bolts <3> and tighten as follows:
  - Bolt <2>: 2 Nm
  - Bolt <3>: 6 Nm (renew)

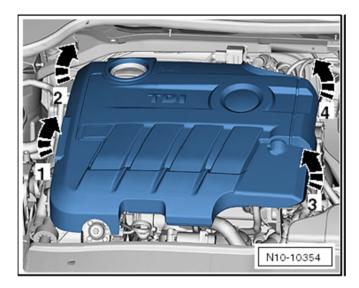
Pull engine cover up out of fastening elements near <arrows> in order shown. To do this, grip as far as possible beneath engine cover.

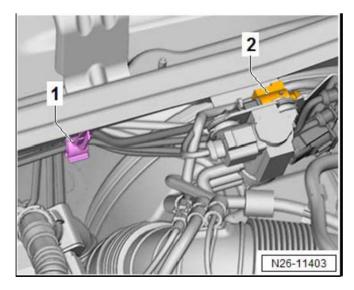
- Disconnect »brown« connector for exhaust gas temperature sender 3 -G495- <2> (secured behind bracket).
- Thread lines out of brackets <1> on plenum chamber bulkhead and on turbocharger.

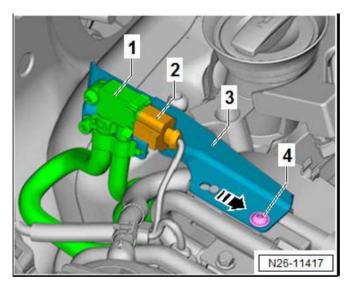
- Pull connector <2> off differential pressure sensor -G505- <1>.
- Remove securing bolt <4>, remove bracket <3> with differential pressure sensor -G505- <1> in <direction of arrow> and move aside. Control lines remain connected.

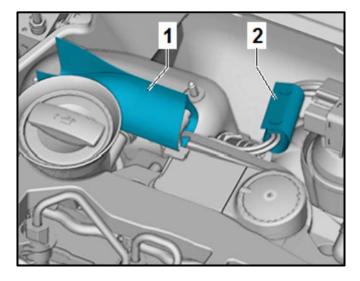
- Open fasteners on heat insulation <1> for exhaust pressure sensor 1 -G450-.
- Open heat insulation <2> for wiring and remove.

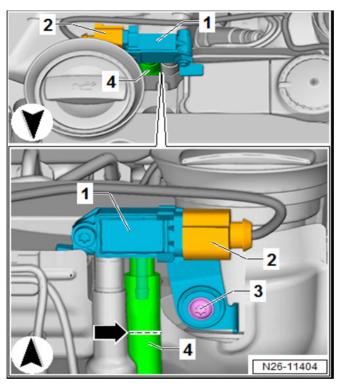
- Pull connector <2> off exhaust pressure sensor 1
   -G450- and remove securing bolt <3>.
- Cut control line <4> to exhaust gas recirculation cooler with an appropriate tool (e.g. utility knife) at the line <arrow> indicated in figure.
- Move bracket with exhaust pressure sensor 1
   -G450- aside (control line to particulate filter remains connected).

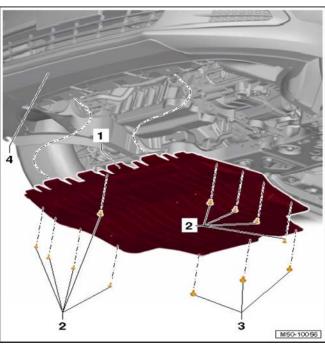
- Remove bolts <2 and 3>.
- Pull noise insulation <1> back, out of front bumper cover <4>.

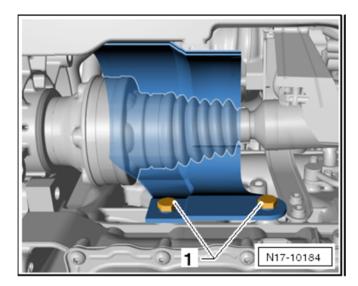
Unscrew bolts <1> and remove heat shield for right drive shaft.

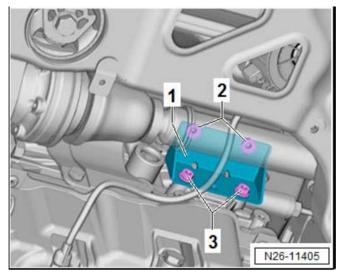
Unscrew securing nuts above bracket <2> with ratchet wrench -T10384-. In some cases, the bracket cannot be removed until the particulate filter has been detached.

Remove nuts <2 and 3> and remove lower bracket for particulate filter <1>.

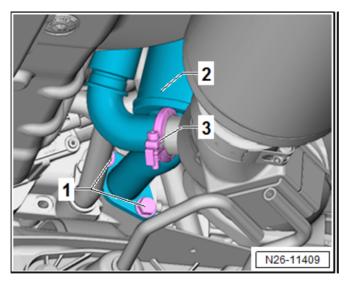
Open clamp <3> and remove it.

The exhaust gas recirculation filter <2> is removed after the particulate filter has been removed.

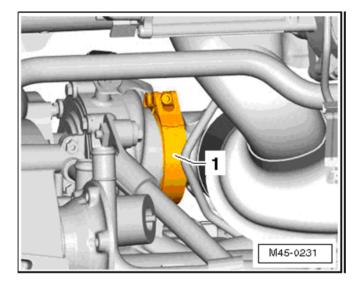
Position of clamp <1> may vary. If necessary, use 5 mm bit with ball head (e.g. T10058).

Loosen and remove clamp <1> connecting turbocharger and particulate filter.

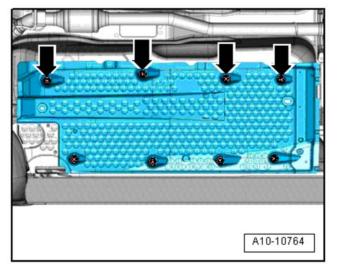
• Unscrew nuts <arrows> and pull underbody cladding on right down slightly.

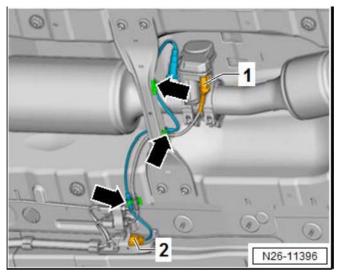
- Disconnect »brown« connector for oxygen sensor after catalytic converter -G130- <2>.
   Remove plug from retainer.
- Open fasteners on heat shield, pull connector
   1> off exhaust door control unit -J883- and thread wiring out of retainers <arrows>.

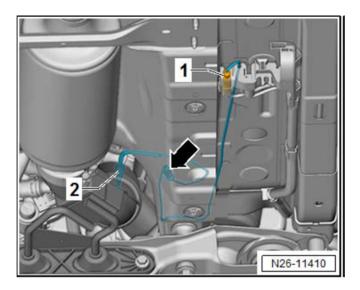
Disconnect connector <1>. Take electrical wire from exhaust gas temperature sensor 4 -G648-<2> on heat shield out of clip <arrow> and bracket and move to side.

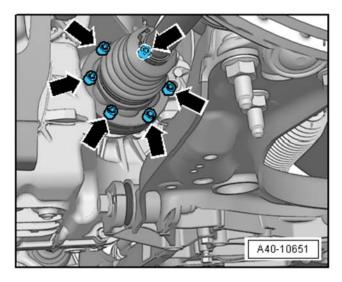
Remove bolts <arrows> and remove right drive shaft from transmission. Rest drive shaft on front axle.

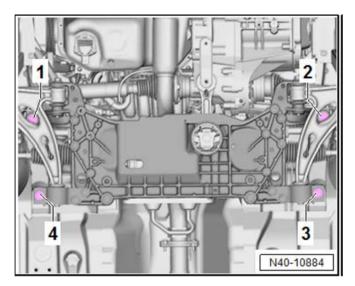
To fix the position of the subframe, the locating pins -T10096- must be screwed one at a time into positions <1, 2, 3 and 4>.

The locating pins -T10096- may be tightened only to max. 20 Nm, or the threads of the locating pins will be damaged.

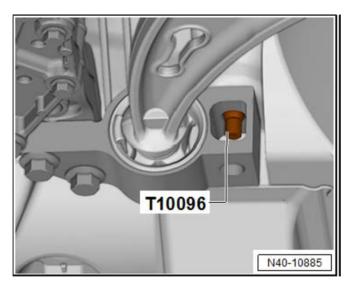
One at a time, remove securing bolts on mounting bracket and replace them with locating pins -T10096- on both sides. Tighten locating pins to 20 Nm.

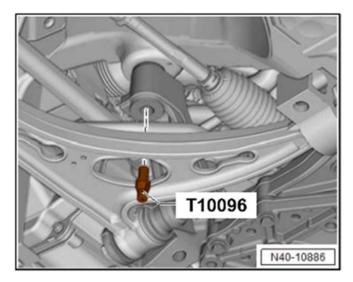
One at a time, replace bolts in brackets with locating pins -T10096-. Tighten locating pins to 20 Nm.

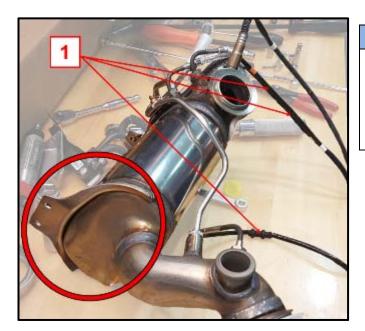
When installing the exhaust gas temperature sensors to the DPF, it is possible to install the sensors <1> in the wrong locations. Sensors installed in the wrong positions will not function properly. Pay attention to the sensor color coding <circle> when installing sensors into the DPF.

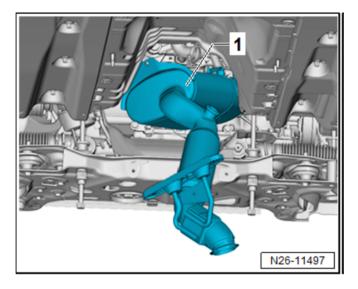
- Do not bend flexible joint more than 10°.
- Install flexible joint free of tension.
- Take care not to damage wire mesh on flexible joint.
- The flexible joint must be secured with transportation lock -T10404- to prevent overstretching.
- Always hold the particulate filter by the heavy casing when transporting or handling it.
  - Loosen nut <arrow> for bracket <1> on top of cylinder head a few turns.

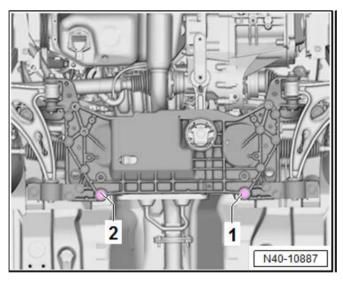
- Raise the subframe until it is approximately 5 cm away from the vehicle chassis and screw in bolt
   on the wire harness bracket for steering gear and tighten to 3 Nm.
- Carefully raise subframe to installation position taking locating pins into consideration.

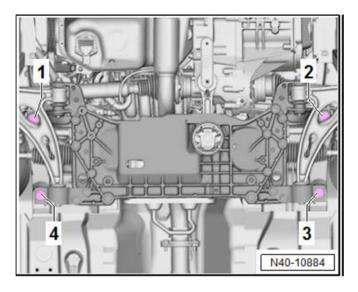
If installed, remove spindles -3346/2- and screw in new bolts (M12 x 110 mm) at positions <1 and 2>. Tighten to 70 Nm and turn an additional 90°.

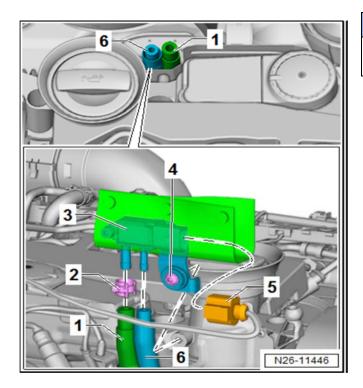
For greater clarity, exhaust pressure sensor 1 -G450-is shown here from behind (perspective of plenum chamber bulkhead).

- 1 Remove bolt <1>.
- 2 Remove and dispose of old pressure sensor <6>
- 3 Insert new pressure sensor <2> into bracket <3>.
- 4 Screw in bolt <1> and tighten to 10 Nm.
- 5 Guide bracket with pressure sensor through openings in new heat shield <4>.

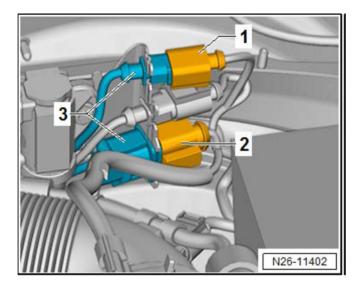
- Connect »brown« connector for exhaust gas temperature sensor 3 -G495- <2> and secure behind bracket.
- Thread lines into brackets <1> on plenum chamber bulkhead and on turbocharger.

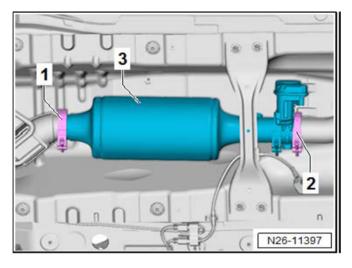
Install clamps on the exhaust pipe before installing pipe into vehicle. Do not attempt to stretch clamps around pipe once installed, or clamps may fail to seal properly.

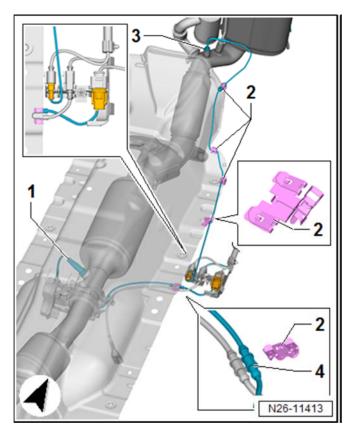
- Connect »brown« connector for oxygen sensor after catalytic converter -G130- <2> and attach to bracket.
- Push connector <1> onto exhaust door control unit. Secure lines in retainers <arrows>.

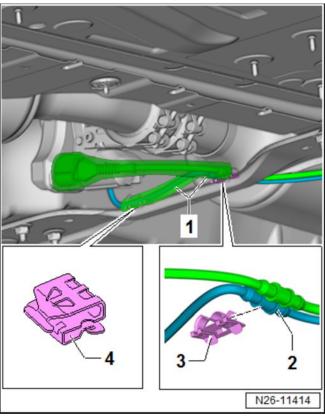
Place electrical wiring from oxygen sensor after catalytic converter -G130- <1> and exhaust gas temperature sensor 4 -G648- <3> in clips <2> on heat shield as shown. Connect connector and secure in bracket.

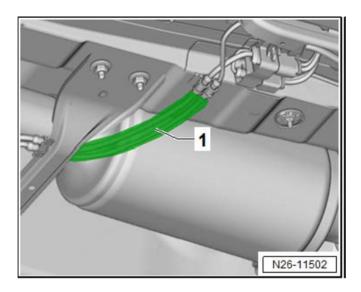
- Wrap new heat insulation mats <1> around wiring and close fasteners.
- Place wires <2> in clips <3 and 4>.

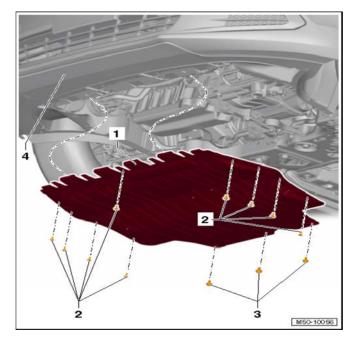
Press underbody cladding upward and tighten nuts <arrows> to 2 Nm.

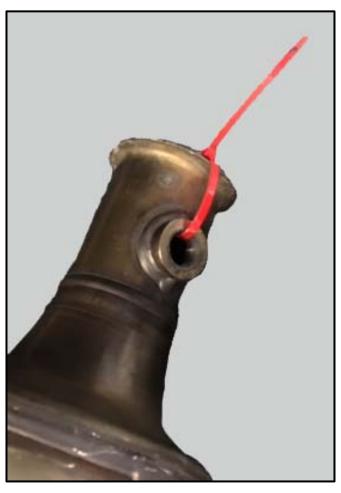
On one-piece DPF with NOx trap system, the NOx trap must be separated from the DPF.

Separate NOx trap from DPF using -VAS6254-Chain Pipe Cutter (or equivalent).

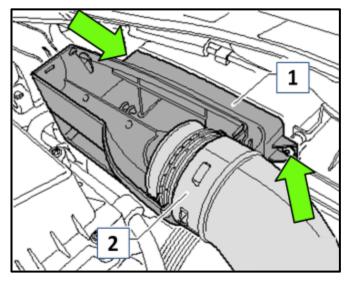
- · Switch ignition off and remove key
- Open hood.
- · Carefully remove engine cover.
- Release the tabs <arrows> and remove the cover on the air intake.

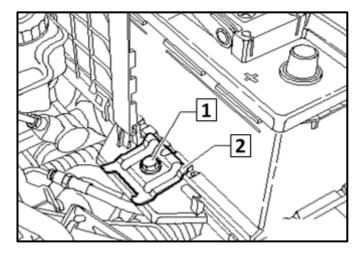
- Disconnect and isolate the ground cable <1> from the battery negative pole.
- Disconnect the positive cable <2> from the battery positive pole.

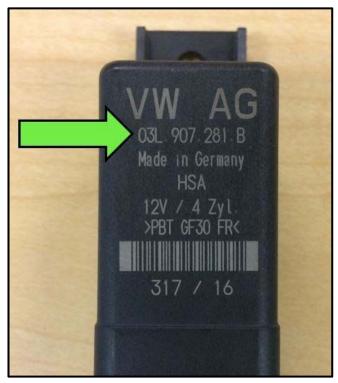
To remove, slide the glow plug control module with bracket <1> outward from underneath the left engine compartment E-box in <direction of arrow>.

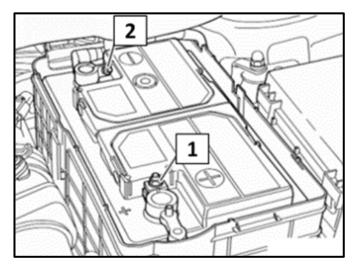
- Reinstall battery.
- Reinstall the clamping plate <2> with bolt <1> and torque to 20Nm.

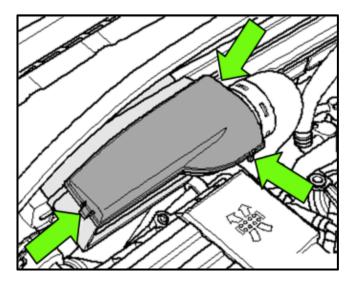
Reinstall the air intake guide <1> and air intake guide hose <2>, then tighten the screws <arrows>.

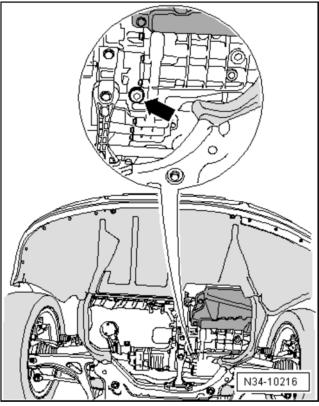
- Do not start engine!
- If required due to fluid contamination, replace the oil filter.

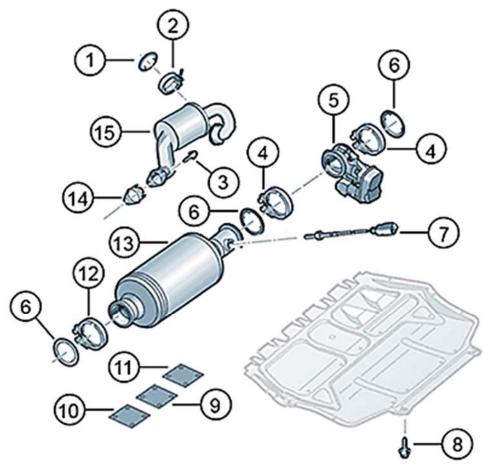
### Criteria 01 and 02 - 2.0L Base Kit 1 - 1K0 298 101 A (All Vehicles)

#	Part	Name	Quantity Required Per Vehicle
1	1K0253115AG	Seal	1
2	1K0253725F	Clamp	1
3	N10642103	Bolt (M8x25)	2
4	1K0253725B	Clamp (narrow)	2
5	1K0253691J	Exhaust door control unit -J883-	1
6	1K0253115AE	Seal	3
7	03L906262N	Oxygen sensor after catalytic converter -G130-	1
8	1K0825951	Bolt self-locking (M6x20)	3
8	WHT000729A	Bolt self-locking (M8x20)	
9	1K0971461D	Heat shield (Cable for Exhaust door control unit –J883-)	
10	1K0971461E	Heat shield (Cable for Oxygen sensor –G130-)	1
11	1K0971461F	Heat shield (Cable for Oxygen sensor and Exhaust door control unit)	1
12	1K0253725	Clamp	1
13	1K0254402AX	NOx storage catalytic converter	1
14	03G131547H	Seal	1
15	1K0253120B	Exhaust gas recirculation filter	1

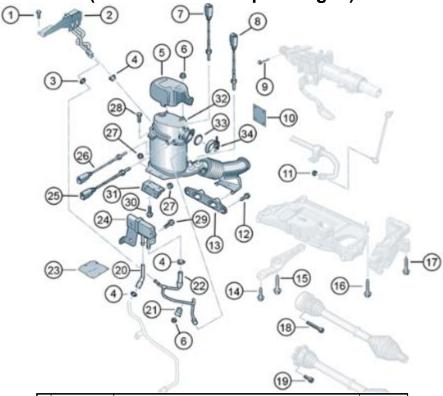
# Criteria 01 ONLY - 2.0L Base Kit 2 - 1K0 298 101 X (2009 Jetta/Jetta SportWagen)

#	Part	Name	Quantity Required Per Vehicle
1	N90737105	Bolt	1
2	1K0131552B	Differential pressure sender -G505-	1
3	3C0131483A	Spring clamp	3
4	4B0422379	Spring clamp	1
5	5N0131783	Heat shield	1
6	N02300215	Nut M6	4
7	03L906262B	Oxygen sensor -G39-	1
8	03L906088EG	Exhaust gas temperature sender –G648-	1
9	N01033513	Bolt for U-joint	1
10	5N0971461	Heat shield	1
11	N0150816	Nut	2
12	N10240003	Bolt (M8x32)	2
13	1K0253144BC	Exhaust system bracket	1
14	N91066101	Bolt (M10x35)	1
15	N91167101	Bolt (M10x75)	1
16	WHT000431A	Bolt M12x110	2
17	N91039802	Bolt M12x90	4
18	N90991102	Bolt (M10x52) - Manual Transmission	6
19	N90991002	Bolt (M10x23) - DSG Transmission	6
20	03G131525	Hose for control line	1
21	1K0131649	Retainer	1
22	1K0131552A	Control line	1
23	1K0971461C	Heat shield	1
24	076906051A	Exhaust pressure sensor 1 -G450-	1
25	03L906088T	Exhaust gas temperature sender – G448-	1
26	03L906088J	Exhaust gas temperature sender – G495	1

27	N01508315	Nut M8	4
28	N10653102	Bolt	1
29	N10456201	Bolt M6x25	1
30	N90786502	Bolt	2
31	1K0253463AF	Bracket	1
32	1K0254708GX	Particulate filter	1
33	04L253115A	Seal	1
34	1K0253725	Clamp	1

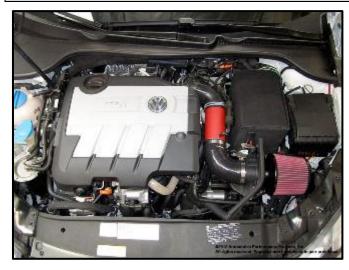
- Perform a visual inspection of the intake, exhaust, and emissions systems.
  - If the visual inspection of the intake, exhaust, or emissions equipment reveals damage or concerns, STOP, create a VTA ticket and contact the Volkswagen Technicians Helpline.
  - If the visual inspection of the intake, exhaust, or emissions equipment reveals no damage or concerns, continue the work procedure.

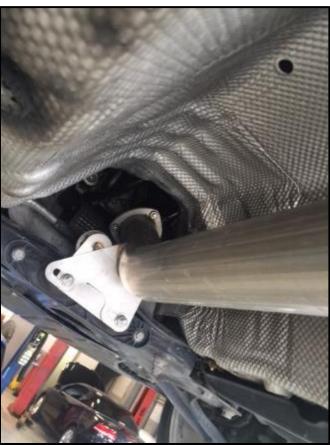
- Check for vehicle modifications from original equipment.
  - If vehicle modifications from original equipment related to emissions components <u>are</u> found, **STOP**, create a VTA ticket and contact the Volkswagen Technicians Helpline.
  - If vehicle modifications from original equipment related to emissions components are <u>not</u> found, continue the work procedure.

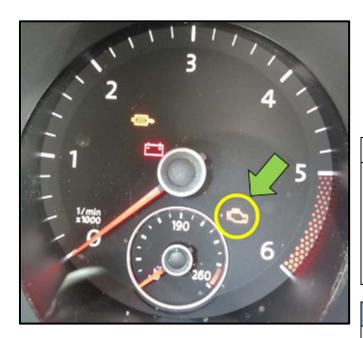
- Check for illumination of the MIL <arrow>.
  - If MIL is illuminated, STOP, create a VTA ticket and contact the Volkswagen Technicians Helpline.
  - If MIL is not illuminated, continue the work procedure.

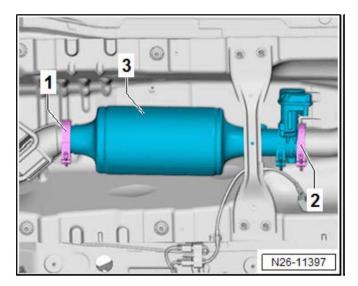
Loosen clamps <1 and 2> and remove NOx storage catalytic converter together with exhaust door control unit -J883-.

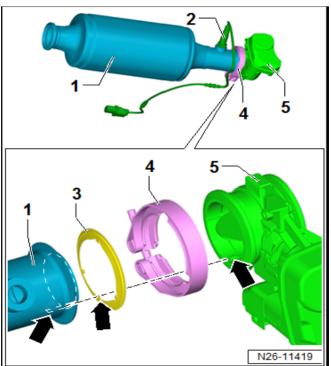
- Screw new oxygen sensor after catalytic converter -G130- <2> into new NOx storage catalytic converter <1> and tighten to 52 Nm using socket, 22 mm -T10491-.
- Set new exhaust door control unit -J883- <5> with new seal <3> on NOx storage catalytic converter <1>. Note notches <arrows>.

Renew all clamps and seals. The clamps before and after the exhaust door control unit are narrower than the clamp connecting the particulate filter to the NOx storage catalytic converter. Ensure that they are correctly allocated.

- Position clamp 1K0 253 725 B <4> and tighten to 7 Nm.
- Place NOx storage catalytic converter together with exhaust door control unit -J883- with new seals in installation position. Note notches at rear connection.

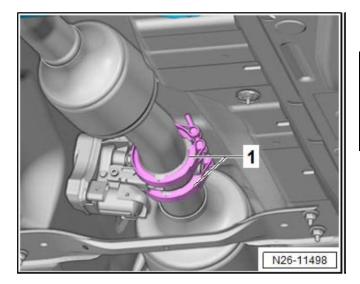
Position all clamps <1> so that they will not collide with underbody.

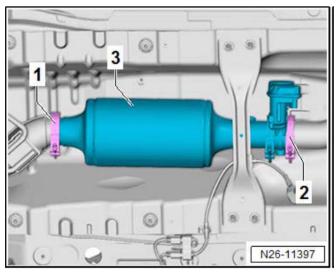
- Set clamp 1K0 253 725 B <2> in place and engage and torque to 7 Nm.
- Set clamp 1K0 253 725 <1> in place and engage. Then tighten to 7 Nm.

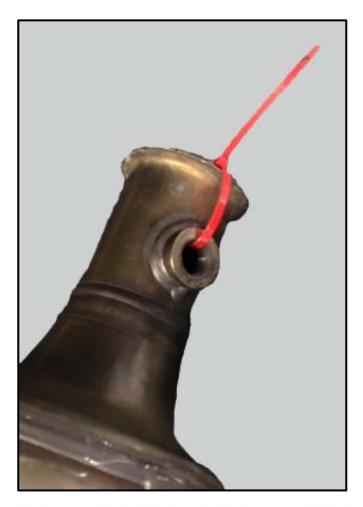
Install the <u>RED</u> validation strap to the NOx catalytic converter <as shown> to confirm that the proper part is being returned for core.

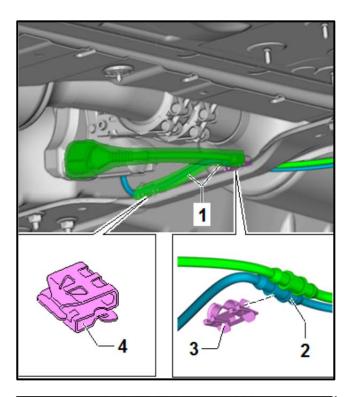
- Wrap new heat insulation mats <1> around wiring and close fasteners.
- Place wires <2> in clips <3 and 4>.

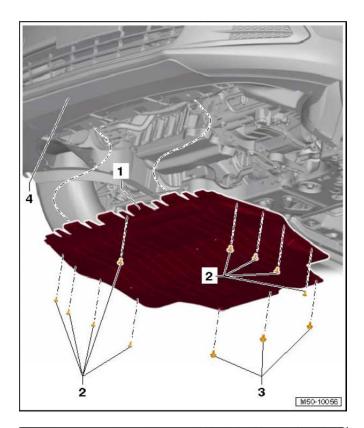
- Remove bolts <2 and 3>.
- Pull noise insulation <1> back, out of front bumper cover <4>.

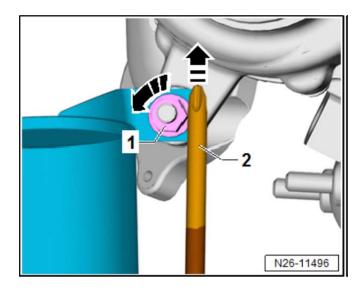
Apply screwdriver <2> on side of nut <1> and unscrew nut while simultaneously pressing up on nut

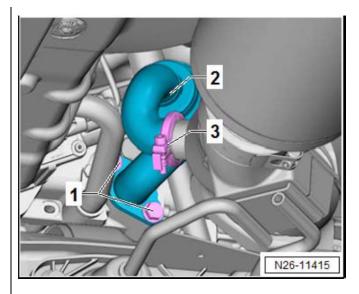
- Set new exhaust gas recirculation filter <2> with new seals in place, screw in bolts <1> and tighten to 9 Nm.
- Position clamp <3> and tighten to 3.5 Nm.

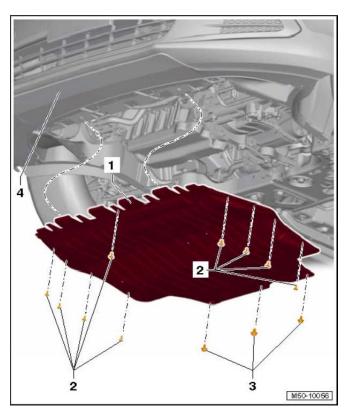
- Push noise insulation <1> forward into front bumper cover <4>.
- Screw in bolts <2> and new bolts <3> and tighten as follows:
  - o Bolt <2>: 2 Nm
  - Bolt <3>: 6 Nm (renew)

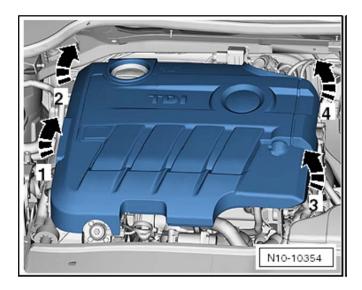
Pull engine cover up out of fastening elements near <arrows> in order shown. To do this, grip as far as possible beneath engine cover.

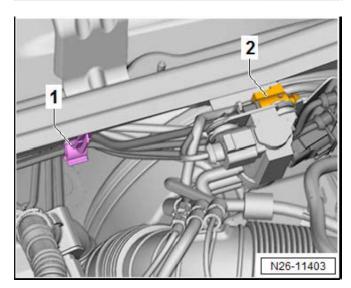
- Disconnect »brown« connector for exhaust gas temperature sender 3 -G495- <2> (secured behind bracket).
- Thread lines out of brackets <1> on plenum chamber bulkhead and on turbocharger.

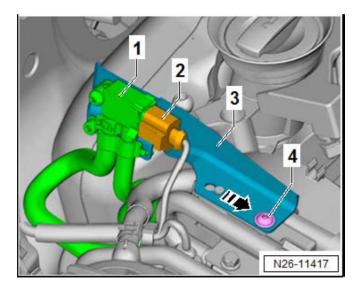
- Pull connector <2> off differential pressure sensor -G505- <1>.
- Remove securing bolt <4>, remove bracket <3> with differential pressure sensor -G505- <1> in <direction of arrow> and move aside. Control lines remain connected.

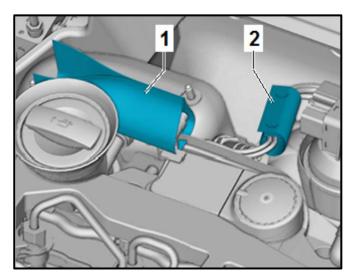
- Open fasteners on heat insulation <1> for exhaust pressure sensor 1 -G450-.
- Open heat insulation <2> for wiring and remove.

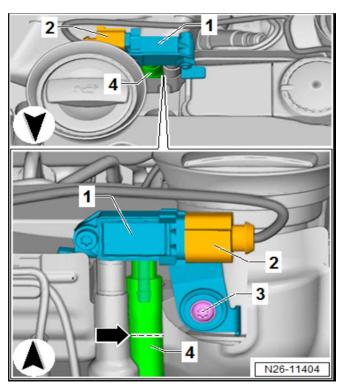
- Cut control line <4> to exhaust gas recirculation cooler with an appropriate tool (e.g. utility knife) at the line <arrow> indicated in figure.
- Move bracket with exhaust pressure sensor 1
  -G450- aside (control line to particulate filter remains connected).

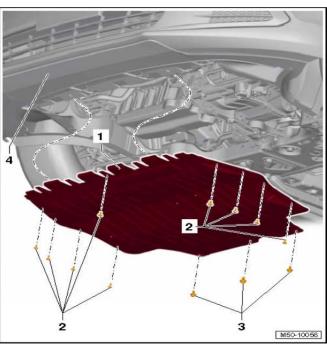
- Remove bolts <2 and 3>.
- Pull noise insulation <1> back, out of front bumper cover <4>.

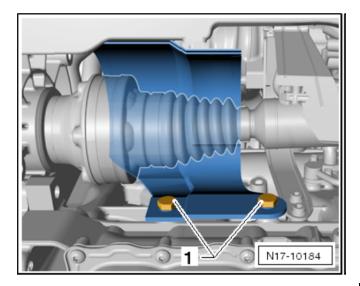
Unscrew bolts <1> and remove heat shield for right drive shaft.

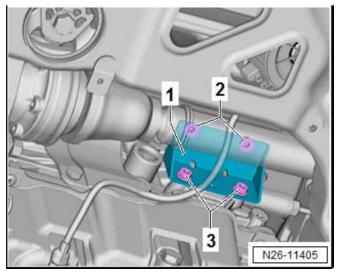
Unscrew securing nuts above bracket <2> with ratchet wrench -T10384-. In some cases, the bracket cannot be removed until the particulate filter has been detached.

Remove nuts <2 and 3> and remove lower bracket for particulate filter <1>.

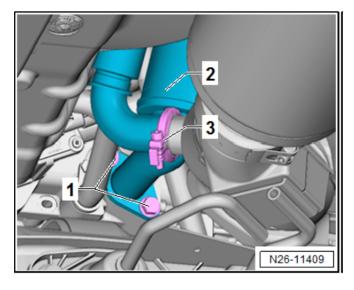
Open clamp <3> and remove it.

The exhaust gas recirculation filter <2> is removed after the particulate filter has been removed.

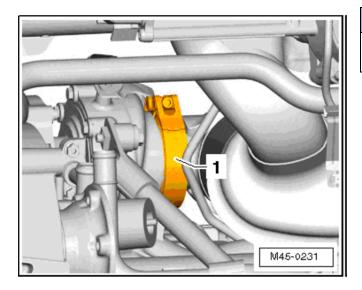
Position of clamp <1> may vary. If necessary, use 5 mm bit with ball head (e.g. T10058).

• Loosen and remove clamp <1> connecting turbocharger and particulate filter.

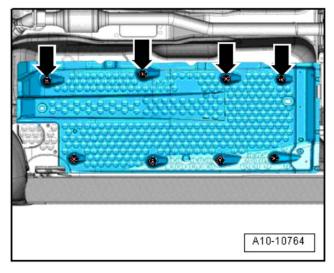
• Unscrew nuts <arrows> and pull underbody cladding on right down slightly.

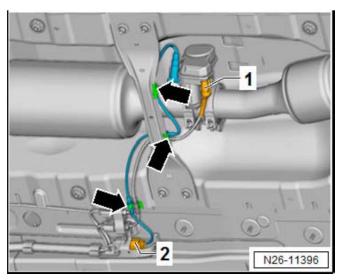
- Disconnect »brown« connector for oxygen sensor after catalytic converter -G130- <2>. Remove plug from retainer.
- Open fasteners on heat shield, pull connector <1> off exhaust door control unit -J883- and thread wiring out of retainers <arrows>.

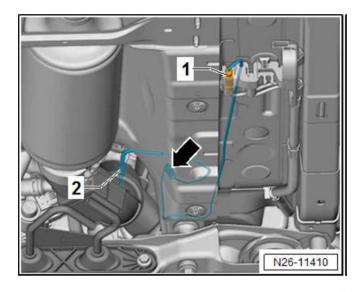
Disconnect connector <1>. Take electrical wire from exhaust gas temperature sensor 4 -G648-<2> on heat shield out of clip <arrow> and bracket and move to side.

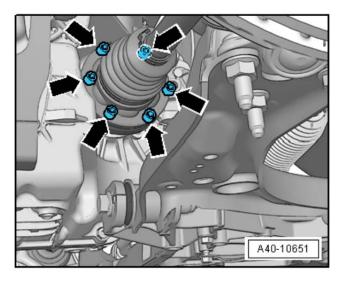
Remove bolts <arrows> and remove right drive shaft from transmission. Rest drive shaft on front axle.

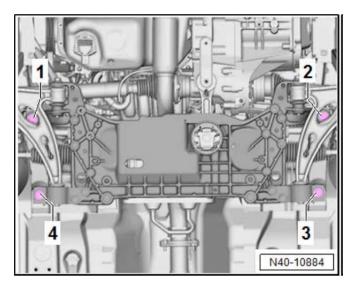
To fix the position of the subframe, the locating pins -T10096- must be screwed one at a time into positions <1, 2, 3 and 4>.

The locating pins -T10096- may be tightened only to max. 20 Nm, or the threads of the locating pins will be damaged.

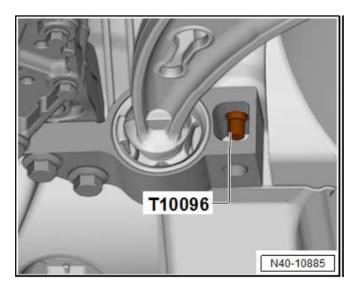
One at a time, remove securing bolts on mounting bracket and replace them with locating pins -T10096- on both sides. Tighten locating pins to 20 Nm.

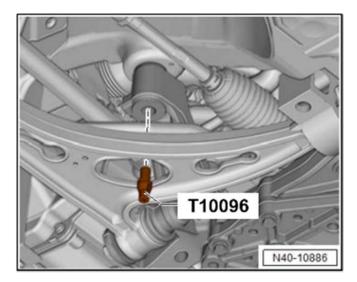
One at a time, replace bolts in brackets with locating pins -T10096-. Tighten locating pins to 20 Nm.

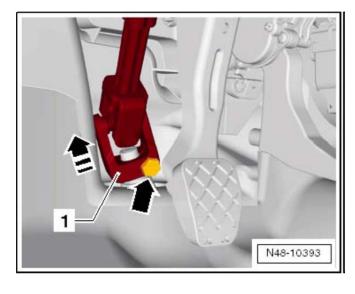
Remove bolt <arrow> from U-joint <1> and pull off U-joint in <direction of arrow>.

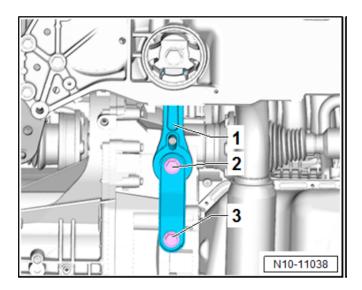
Remove bolts <2 and 3> for pendulum support
 <1> from gearbox.

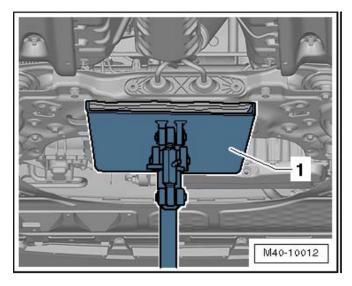
Place engine and gearbox jack -VAS 6931- <1> under subframe.

Secure the subframe in position on the engine and gearbox jack -VAS 6931- using the included retaining strap if you are **NOT** utilizing the Screw Nuts -3346/3- and Spindles -3346/2- listed in the next steps.

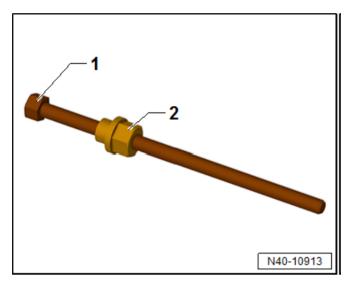
Optional method for securing, raising, and lowering the subframe utilizing Screw Nuts -3346/3- <2> and Spindles -3346/2- <1>:

Install Screw Nuts -3346/3- <2> by hand as shown onto spindles -3346/2- <1> to the end of threads as shown.

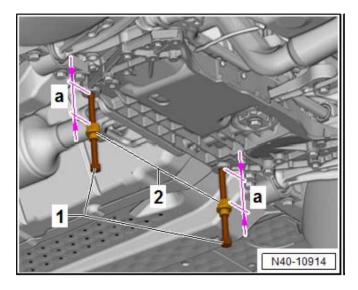
Screw in spindles 3346/2 <1> by hand until distance <a> equals 90 mm.

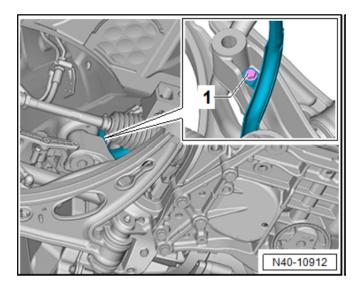
Lower subframe about 5cm and remove bolt <1> on the wire harness bracket for steering gear.

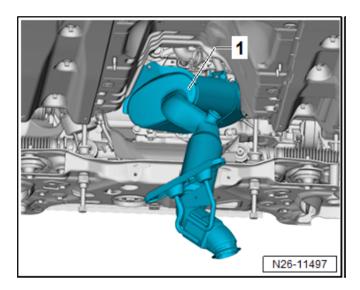
With the help of a second technician, remove particulate filter. Do this by turning the particulate filter <1> out of center tunnel. Note electrical wiring and components when doing this.

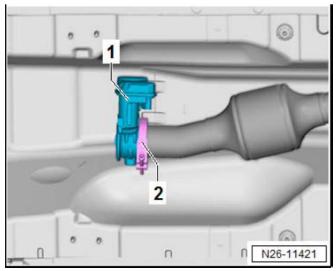
Open clamp <2> and remove exhaust door control unit <1>.

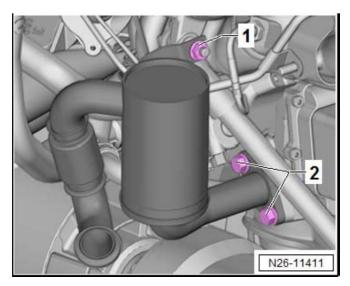
Remove nut <1> and bolts <2>, and remove exhaust gas recirculation filter.

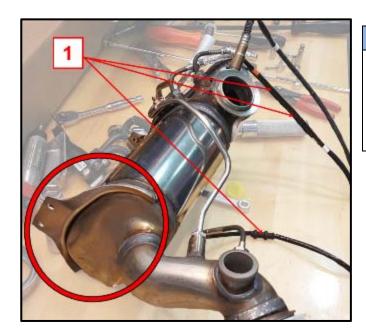
When "bench-installing" the exhaust gas temperature sensors to the DPF, the edge of the lower bracket <circle> can damage the sensor wires <1> if they are allowed to get underneath the bracket while positioning the DPF. Pay special attention to the sensor wiring to prevent damage to these sensors.

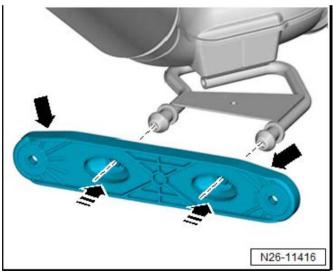
Press bracket in <direction of arrow> onto pins of particulate filter. The bracket edge which tapers towards the ends <arrows> must face upwards.

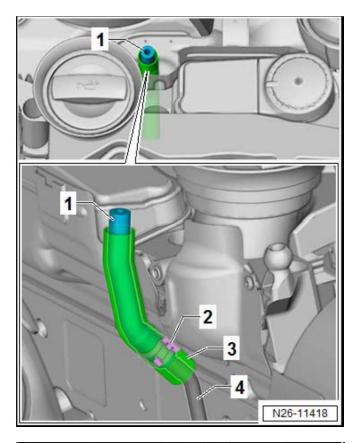
# Renewing hose for control line exhaust pressure sensor 1 -G450-

- Remove heat shield <3>.
- Open clamp <2> and pull hose which was cut during removal <1> from control line <4>.
- Renew hose <1> and tighten clamp <2>. Push heat insulation <3> over hose and clamp.

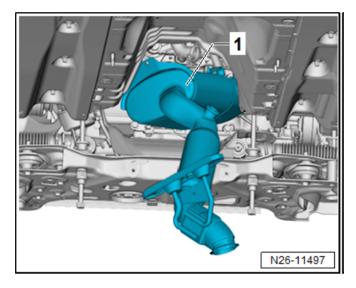
- Position new clamp 1K0 253 725 over the intake funnel of the particulate filter. Orient new clamp (positioned downward) to the same clocking as the original clamp.
- Move particle filter into installation position by »turning« it into center tunnel. Take care not to damage electrical wiring or components.

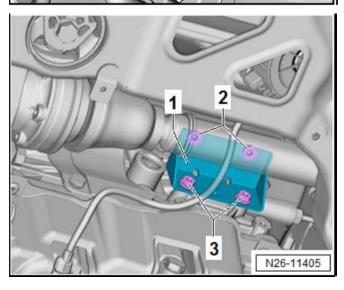
Unlike the production bracket, the supplied bracket no longer has threaded studs. It must be screwed to the particulate filter using the supplied bolts, and the nuts must be screwed on from below. The ball indentation on the bracket faces the crankcase.

- Hold bracket in place and start new bolts for nuts
   in bracket from above.
- Start nuts <3 and 2> by hand a few full turns.

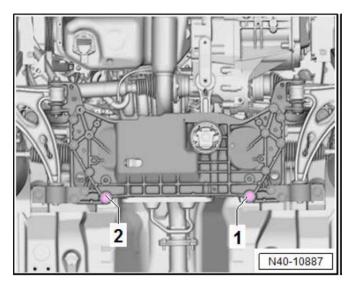
If installed, remove spindles -3346/2- and screw in new bolts (M12 x 110 mm) at positions <1 and 2>. Tighten to 70 Nm and turn an additional 90°.

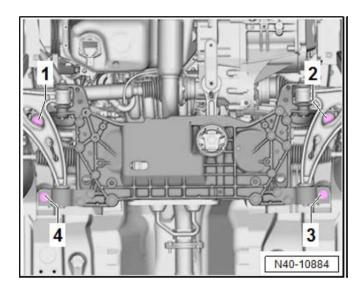
- Remove locating pins one at a time and replace them with new bolts (M12 x 90 mm) at locations
   1, 2, 3, and 4>.
- Tighten bolts to 70 Nm, then tighten them an additional 90°.
- Take load off engine and gearbox jack
   -VAS 6931-, disconnect the securing strap, and remove it from work area.

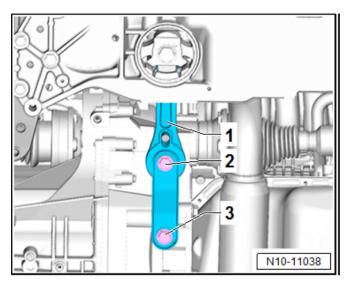
Screw in new bolts <2 and 3> for pendulum support <1>, tighten them to 50 Nm and then tighten and additional 90°.

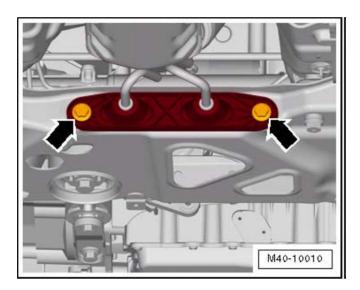
Screw new bolts <arrows> loosely into exhaust system bracket on subframe.

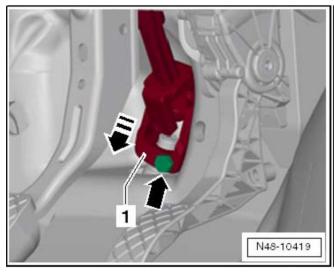
Fit U-joint in <direction of arrow>, screw in new bolt <arrow> for U-joint <1> and tighten to 30 Nm.

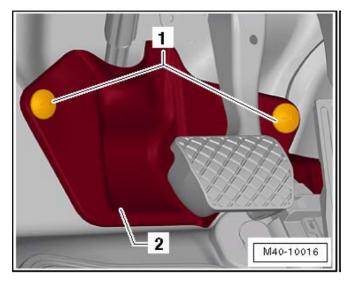
Position footwell trim <2> and hand-tighten bolts <1>.

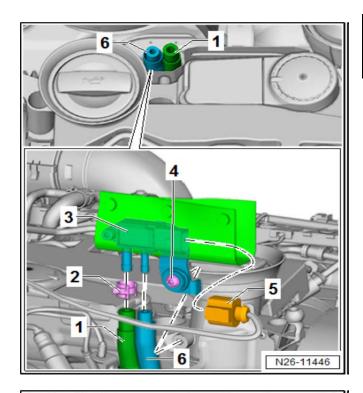
For greater clarity, exhaust pressure sensor 1 -G450is shown here from behind (perspective of plenum chamber bulkhead).

- 1 Remove bolt <1>.
- 2 Remove and dispose of old pressure sensor <6>.
- 3 Insert new pressure sensor <2> into bracket <3>.
- 4 Screw in bolt <1> and tighten to 10 Nm.
- 5 Guide bracket with pressure sensor through openings in new heat shield <4>.

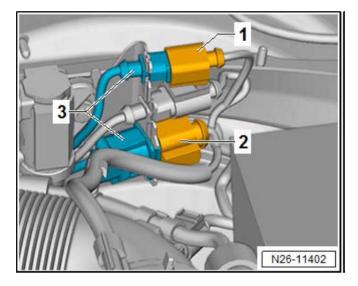
Connect »orange « connector for exhaust gas temperature sensor 2 -G448- <1> and »black « connector for heated oxygen sensor -G39- <3> on plenum chamber bulkhead and secure wiring <3> in retainer.

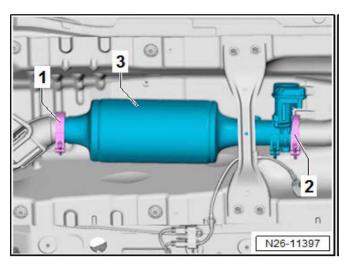
- Set clamp 1K0 253 725 B <2> in place and engage. Then tighten to 7 Nm.
- Set clamp 1K0 253 725 <1> in place and engage. Then tighten to 7 Nm.

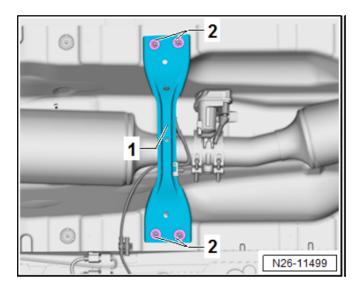
• Set front tunnel cross-piece <1> in place, screw on hexagon nuts <2> and tighten to 20 Nm.

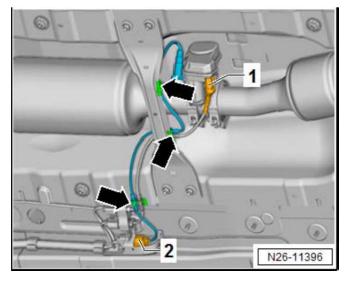
- Connect »brown« connector for oxygen sensor after catalytic converter -G130- <2> and attach to bracket.
- Push connector <1> onto exhaust door control unit. Secure lines in retainers <arrows>.

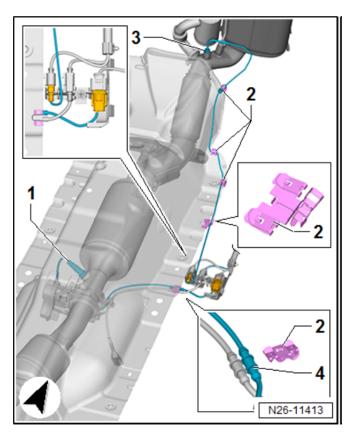
Place electrical wiring from oxygen sensor after catalytic converter -G130- <1> and exhaust gas temperature sensor 4 -G648- <3> in clips <2> on heat shield as shown. Connect connector and secure in bracket.

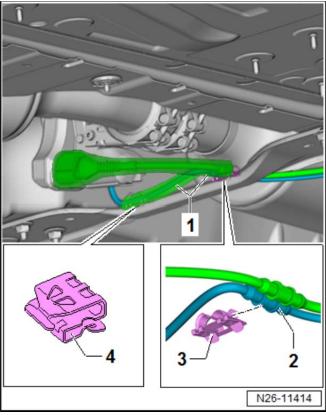
- Wrap new heat insulation mats <1> around wiring and close fasteners.
- Place wires <2> in clips <3 and 4>.

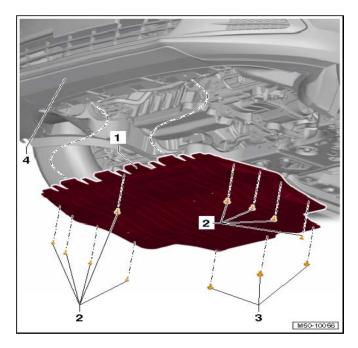
- Push noise insulation <1> forward into front bumper cover <4>.
- Screw in bolts <2> and new bolts <3> and tighten as follows:

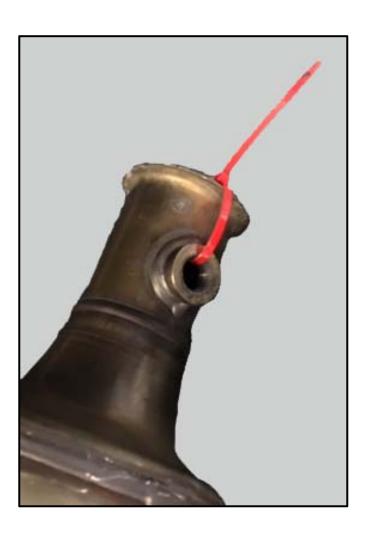
- Install the <u>RED</u> validation strap to the NOx catalytic converter <as shown> to confirm that the proper part is being returned for core.
- Return just the NOx trap catalytic converter. You
  may reuse the packaging that the new NOx trap
  catalyst was shipped in. There is no need to
  return the DPF for core.

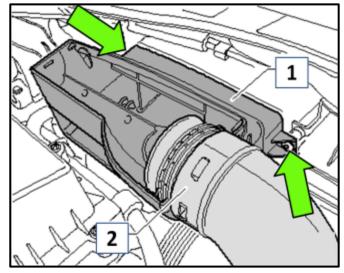
Remove the screws <arrows> for the air intake guide <1> and pull the guide hose <2> out of the air intake guide <1>.

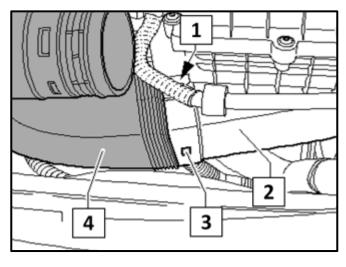
Press the tabs <1 and 3> and remove the air guide hose <4> from the lower air filter housing <2>.

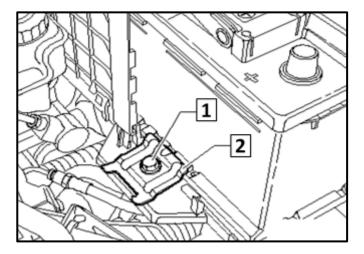
• Remove the bolt <1> and then remove the clamping plate <2>.

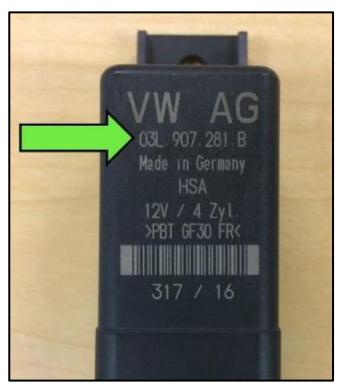
To remove, slide the glow plug control module with bracket <1> outward from underneath the left engine compartment E-box in <direction of arrow>.

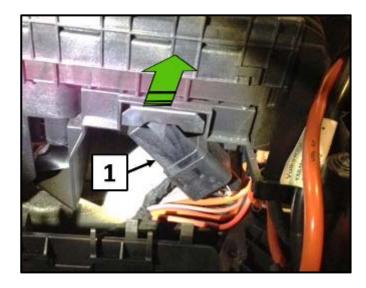
- Inspect, and if required, replace the glow plug control module based upon the part number.
  - If part number "03L 907 281 B" <arrow>
    is present, continue the work procedure
    and reinstall the glow plug control
    module.
  - If part number "03L 907 281 B" <arrow>
    is not present, you are required to
    replace the glow plug control module
    with part number 03L 907 281 B.
    - If the glow plug control module requires replacement, disconnect electrical connector, remove screw with bracket and reinstall onto new glow plug control module with part number 03L 907 281 B.

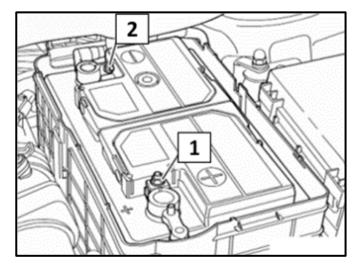
- Reinstall battery.
- Reinstall the clamping plate <2> with bolt <1> and torque to 20Nm.

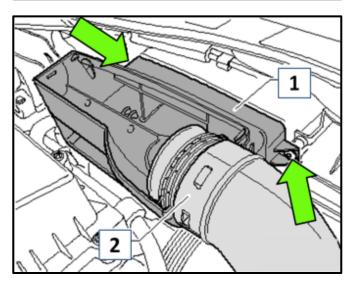
Reinstall the air guide hose <4> onto the lower air filter housing <2>.

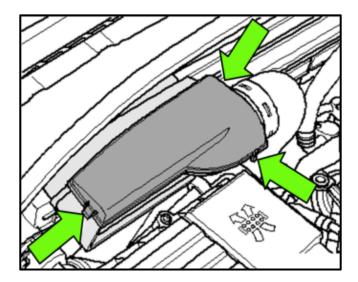
Reinstall the air intake guide <1> and air intake guide hose <2>, then tighten the screws <arrows>.

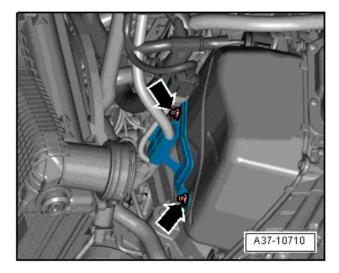
- Do not touch the contacts in the connector of the mechatronic unit for dual clutch -J743- by hand
- Electrostatically discharge by touching a grounded object by hand (without gloves).
- Release locking mechanism of connector <1> for mechatronic unit by turning it in counterclockwise direction, then and pull off the connector.

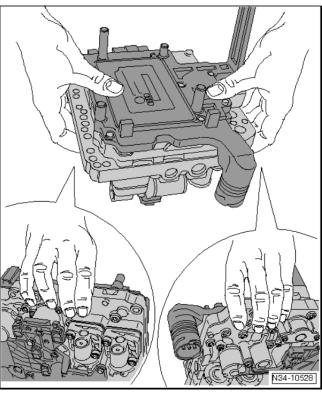
- Carefully pull mechatronic unit out of gearbox housing so that sender arm <B> on back is no longer in gearbox housing.
- When handling mechatronic unit, pay special attention to the "long" sender arm <B>.
- Carefully swing mechatronic unit for dual clutch gearbox -J743- downwards.

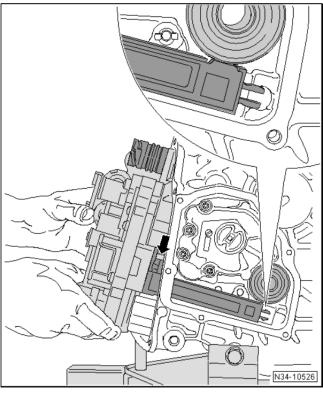
- Mechatronic unit for dual clutch gearbox -J743and gearbox should be at same temperature.
   This stops pins from "jamming" during insertion.
- Before installation of mechatronic unit, make certain that gearbox input speed sender -G182- with oil temperature sender in multiplate clutch -G509- is installed.
- Do not pinch wiring.

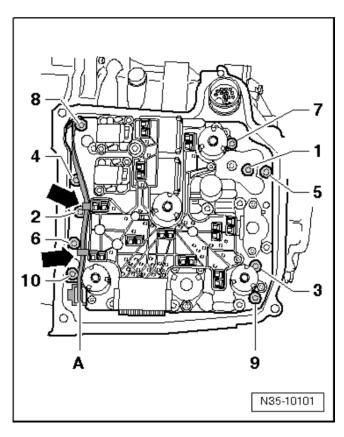
- Carefully place mechatronic unit on dowel pins <arrow> of gear housing. Ensure that "sender arm" locates and locks into position <inset image>.
- Hold mechatronic unit upwards for this purpose, as shown.
- Sender arm is not allowed to strike the sender wheel.
- Verify that the mechatronic unit has made contact correctly before continuing.

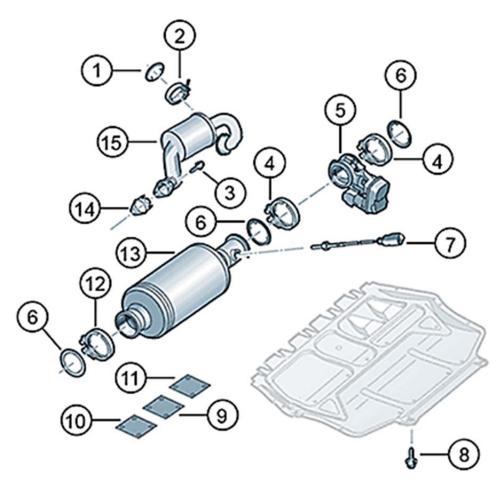
# Criteria 01 and 02 - 2.0L Base Kit 1 - 1K0 298 101 A (All Vehicles)

#	Part	Name	Quantity Required Per Vehicle
1	1K0253115AG	Seal	1
2	1K0253725F	Clamp	1
3	N10642103	Bolt (M8x25)	2
4	1K0253725B	Clamp (narrow)	2
5	1K0253691J	Exhaust door control unit -J883-	1
6	1K0253115AE	Seal	3
7	03L906262N	Oxygen sensor after catalytic converter -G130-	1
8	1K0825951	Bolt self-locking (M6x20)	3
8	WHT000729A	Bolt self-locking (M8x20)	3
9	1K0971461D	Heat shield (Cable for Exhaust door control unit –J883-)	1
10	1K0971461E	Heat shield (Cable for Oxygen sensor –G130-)	1
11	1K0971461F	Heat shield (Cable for Oxygen sensor and Exhaust door control unit)	1
12	1K0253725	Clamp	1
13	1K0254402AX	NOx storage catalytic converter	1
14	03G131547H	Seal	1
15	1K0253120B	Exhaust gas recirculation filter	1

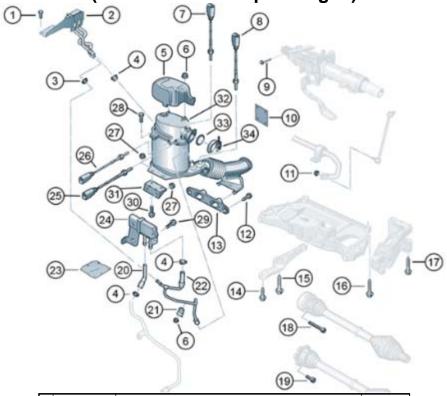
# Criteria 01 ONLY - 2.0L Base Kit 2 - 1K0 298 101 X (2009 Jetta/Jetta SportWagen)

#	Part	Name	Quantity Required Per Vehicle
1	N90737105	Bolt	1
2	1K0131552B	Differential pressure sender -G505-	1
3	3C0131483A	Spring clamp	3
4	4B0422379	Spring clamp	1
5	5N0131783	Heat shield	1
6	N02300215	Nut M6	4
7	03L906262B	Oxygen sensor -G39-	1
8	03L906088EG	Exhaust gas temperature sender –G648-	1
9	N01033513	Bolt for U-joint	1
10	5N0971461	Heat shield	1
11	N0150816	Nut	2
12	N10240003	Bolt (M8x32)	2
13	1K0253144BC	Exhaust system bracket	1
14	N91066101	Bolt (M10x35)	1
15	N91167101	Bolt (M10x75)	1
16	WHT000431A	Bolt M12x110	2
17	N91039802	Bolt M12x90	4
18	N90991102	Bolt (M10x52) - Manual Transmission	6
19	N90991002	Bolt (M10x23) - DSG Transmission	6
20	03G131525	Hose for control line	1
21	1K0131649	Retainer	1
22	1K0131552A	Control line	1
23	1K0971461C	Heat shield	1
24	076906051A	Exhaust pressure sensor 1 -G450-	1
25	03L906088T	Exhaust gas temperature sender – G448-	1
26	03L906088J	Exhaust gas temperature sender – G495	1
